Mobile Intel® 945 Express Chipset Family

Specification Update

November 2007

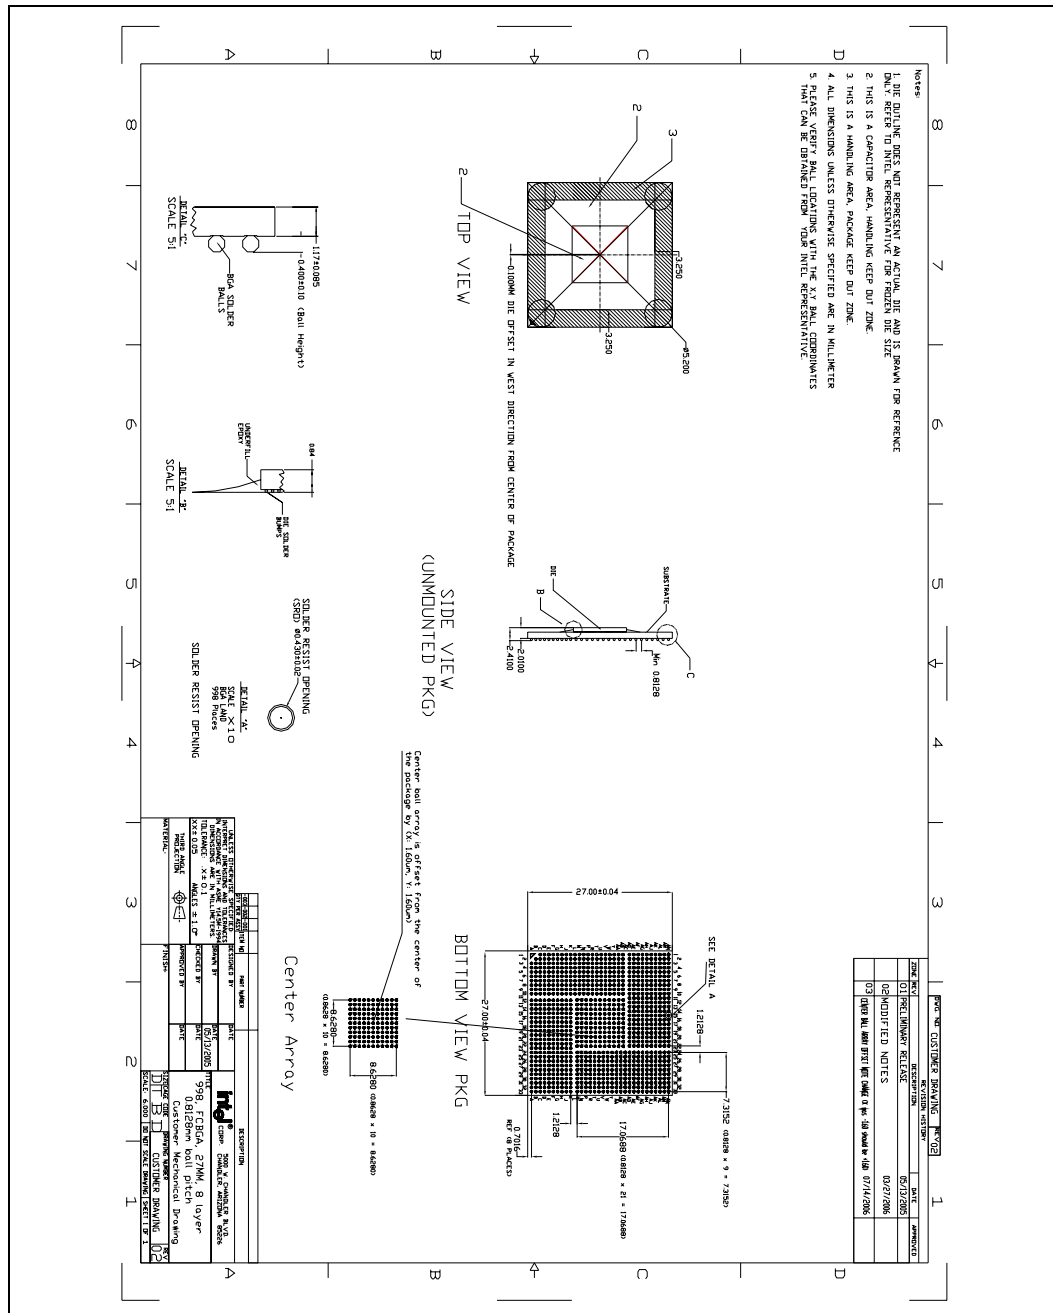
Figure 37. Mobile Intel 945GMS Express Chipset Package FCBGA

The Center Array view has been changed from Top View to bottom view.

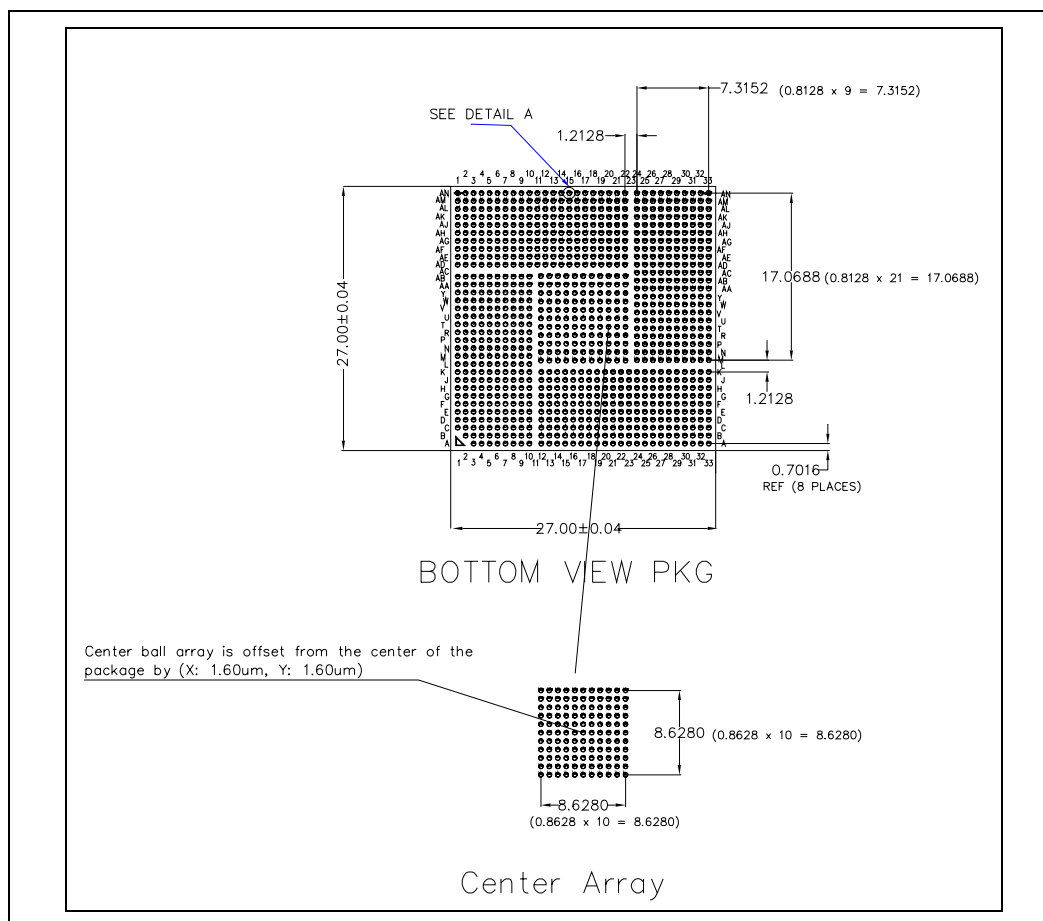
Figure 40. Mobile Intel 945GMS Express Chipset Package FCBGA (Bottom View)

The Center Array view was incorrectly shown from the Top. This has been changed to bottom view. The offset information has also been accordingly updated.
